POND ISSUES

Here: Overflow Drainage Chal

1. The Overflow Drainage Chal:

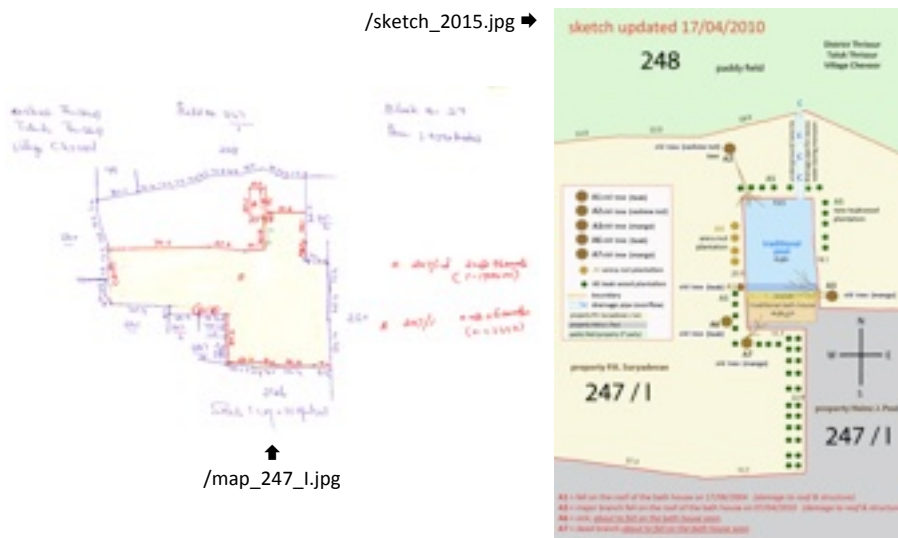
TABLE 1: Location Of The Pond And The Drainage Chal¹

The about 200 years old traditional pond (tank, [kollam]), located at the northern end of my property, survey No. 247/I, has an overflow provision built into the northern laterite foundation wall.

During monsoon, when the water in the pond has reached to a level of about 1 meter beyond the property ground level, a chal, built out of solid laterite stones, drains the excess water to the next paddy field which comes under survey no. 248 as per the sketch of District Thrissur, Taluk Thrissur, Village Chevoor.

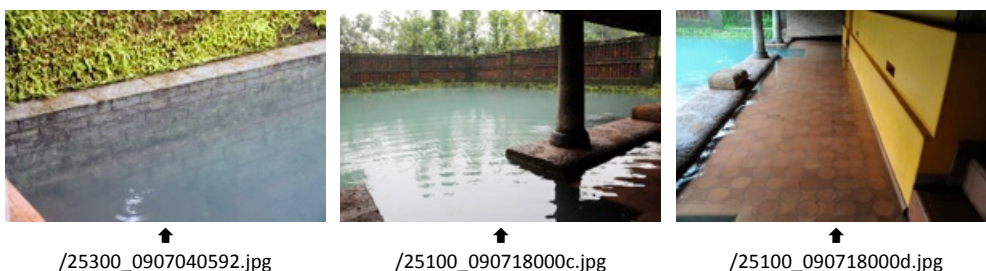
TABLE 3: Submersion Of The Monument After The Blocking Of The Drainage Chal

In September 2010 I observed that the Overflow Drainage Chal has been blocked by the respondent. Consequently during monsoon the water since this time has no way to go anymore and submerses the veranda of the bath house (kollappura) every year; the bath house is also an about 200 years old monument attached to the traditional pond.

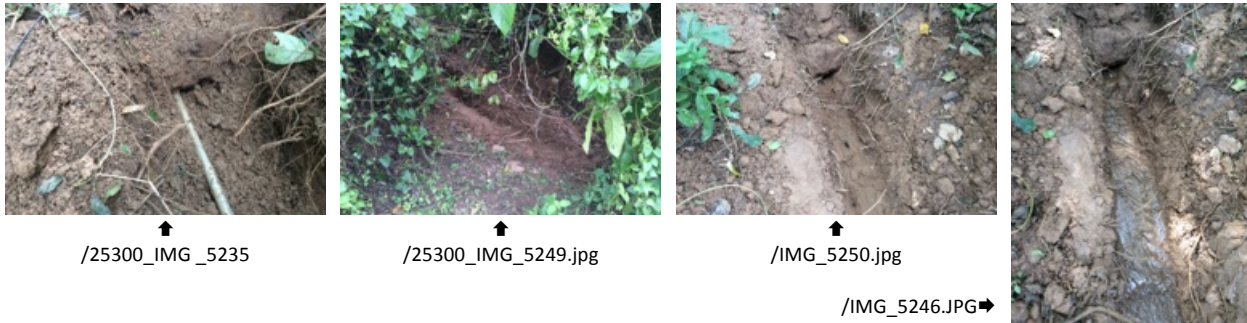
TABLE 4: Entry Of The Overflow Drainage Chal | View Into The Inside Of The Drainage Chal

- a) In a first effort to remove the blockage, a plastic pipe of \varnothing 13 cm diameter was pushed through the laterite drainage chal. While 12 meter plastic pipe could this way be pushed through the drainage pipe, an unknown obstacle prevented top push the plastic pive further towards the outlet.
- b) In a second effort a 20mm galvd. pipe of 15 meter length was pushed through the plastic pipe. With some effort the metal pipe could be pushed through the blockage and reached the paddy field. Subsequently water was pumped into the metal pipe into the unblocked outlet of the drainage chal.
- c) The drainage pipe had been filled at the outlet into the paddy field with rubbles, stones and mud; the outlet was also buried under a heap of rubbles, stones and mud. By removing these blockages the free flow of the water was restored.
